## Case Study: No Snap Decisions

*This issue's case study was contributed by Dave Heinzen.*

**Counter Point** is a quarterly publication of Airtex Engine Management, P.O. Box 70, Fond du Lac, WI 54936-0070. Letters and comments should be directed to: **Counter Point** Editor, c/o Airtex Engine Management, P.O. Box 70, Fond du Lac, WI 54936-0070.

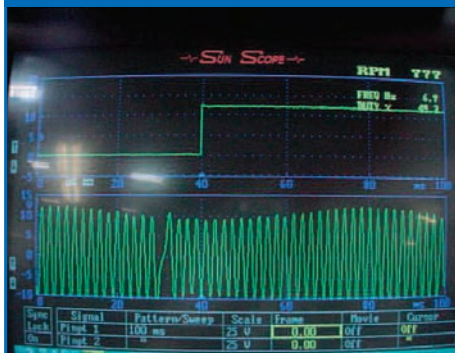
We pulled out a lab scope. A dual trace of the cam and crank sensors revealed the waveforms shown in Figure 1. You can see the sync pulse of the crank sensor and its relationship to the cam sensor, but this information means nothing if you don't know how it's supposed to look. So we hopped on the Internet, hoping that someone had saved a "known-good" cam/crank relationship waveform for one of these 3.8's. We got lucky and found a '95 Mustang 3.8 known-good.

Figure 1: Bad cam and crank sensor SYNC waveforms.

The cam sensor is a different design on the Mustang. But assuming nothing is different with the logic on these shaft sensors from one platform to another, it appeared we were off by 50 degrees. The crank sensor reluctor has a tooth every 10 degrees, with one missing for the sync — for a total of 35 teeth. It looked like it was time to pull the front cover.

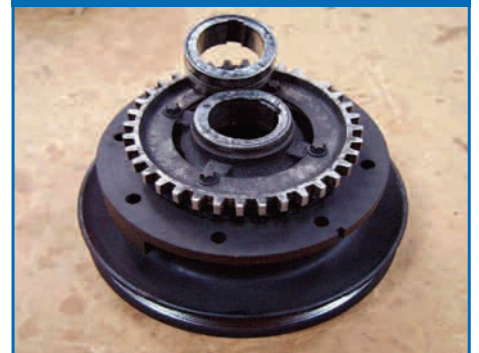
Figure 2 says it all. The hub of the balancer had broken off, allowing the balancer to spin in relation to the crank, then grab again. It probably stopped where it did because the engine could not develop enough torque to spin it any further. This is not a case of a balancer spinning on the rubber insulator. That would not have caused this problem since the reluctor is bolted to the center of the balancer.

Figure 2: Broken crank balancer and reluctor.

After a new balancer and an oil change, the Windstar ran great, rattling cat and all. But with the engine's normal torque restored, we could clearly hear a nasty rod knock. Good thing we didn't throw a bunch of parts at it.
